Case Study

American Transmission Company

Thermal Rating Analysis

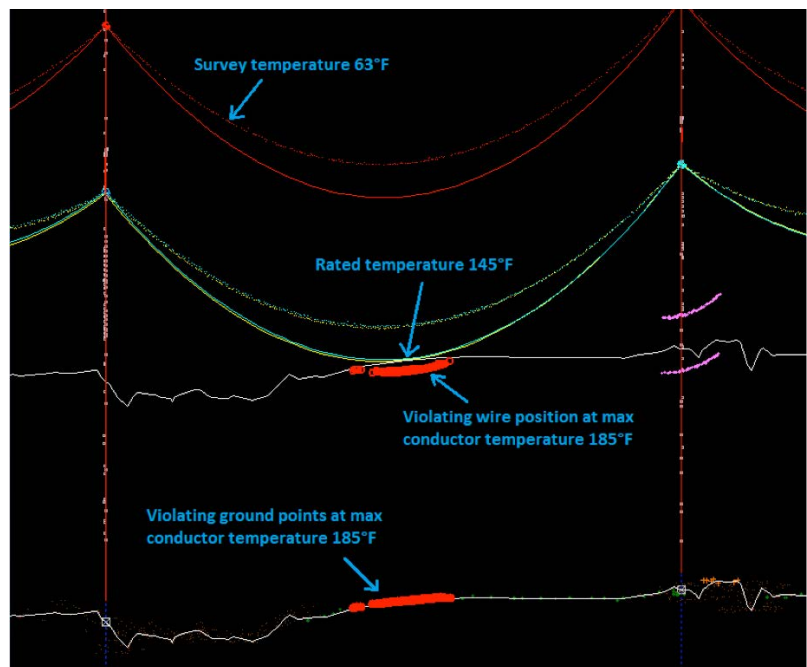
Calculation of base wire temperature and identifying clearance violations

Manitoba Hydro International Ltd. (MHI) has developed thermal rating reports for ATC that illustrate the maximum safe operating temperature of conductors to find the real capacity of transmission lines. These reports show where ground/object clearance violations occur when utilities start pushing more load through their lines to meet peak demand.

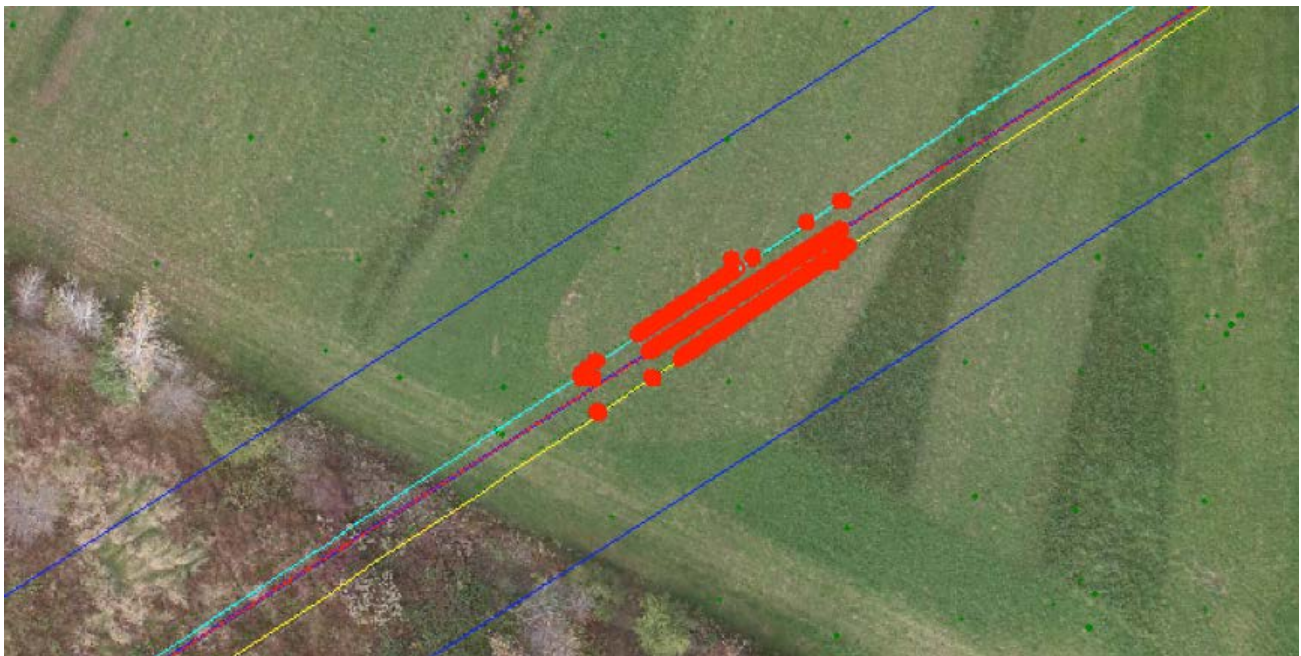
Plan view of a ground violation

By illustrating clearance violations of the lines, MHI is able to recommend solutions to ATC to mitigate these violations. These solutions lead to greater reliability in the transmission system.
